POINT RICHARDS BOAT RAMP

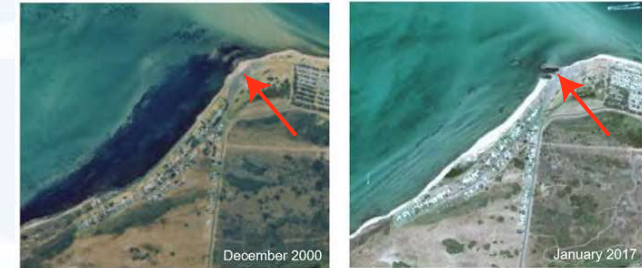
Figure 1: Existing situation Point Richards Seagrass Meadow

- Seagrass detach from the Point Richard Meadow
- The Meadow is currently growing and fluctuates with dry and wet climatic conditions (Figure 1)
- Alongshore ebb currents trap seagrass at the boat ramp
- Weak flood currents cannot flush seagrass out
- A sandbar gradually moves between breakwater heads
- This sandbar can only be dredged with specialist equipment

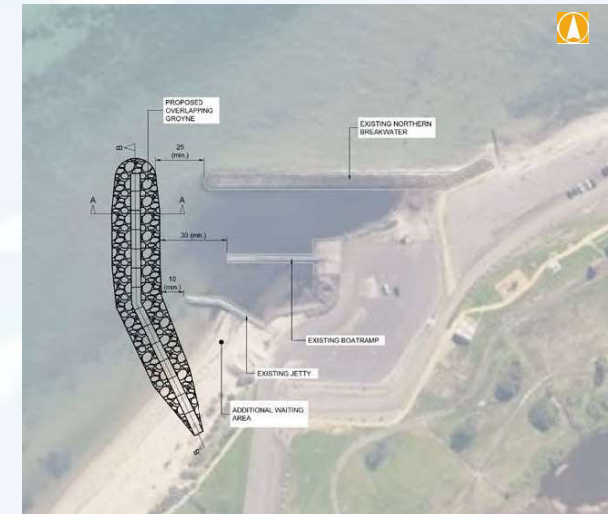
Figure 2: Proposed Breakwater Concept - Plan View

Three possible breakwater configurations were modelled and studied to reduce the accumulation of wrack near the ramp. The most effective configuration reducing seagrass ingress at the boat ramp consists of a deflector to the west of the existing boat ramp (Figure 2 and Figure 3).

Drifting seagrass leaves are deflected into Port Phillip Bay. Alongshore sand is trapped west of the boat ramp. Natural sedimentation will continue across the entrance; however, the deflector provides a convenient access for maintenance dredging of this sandbar.

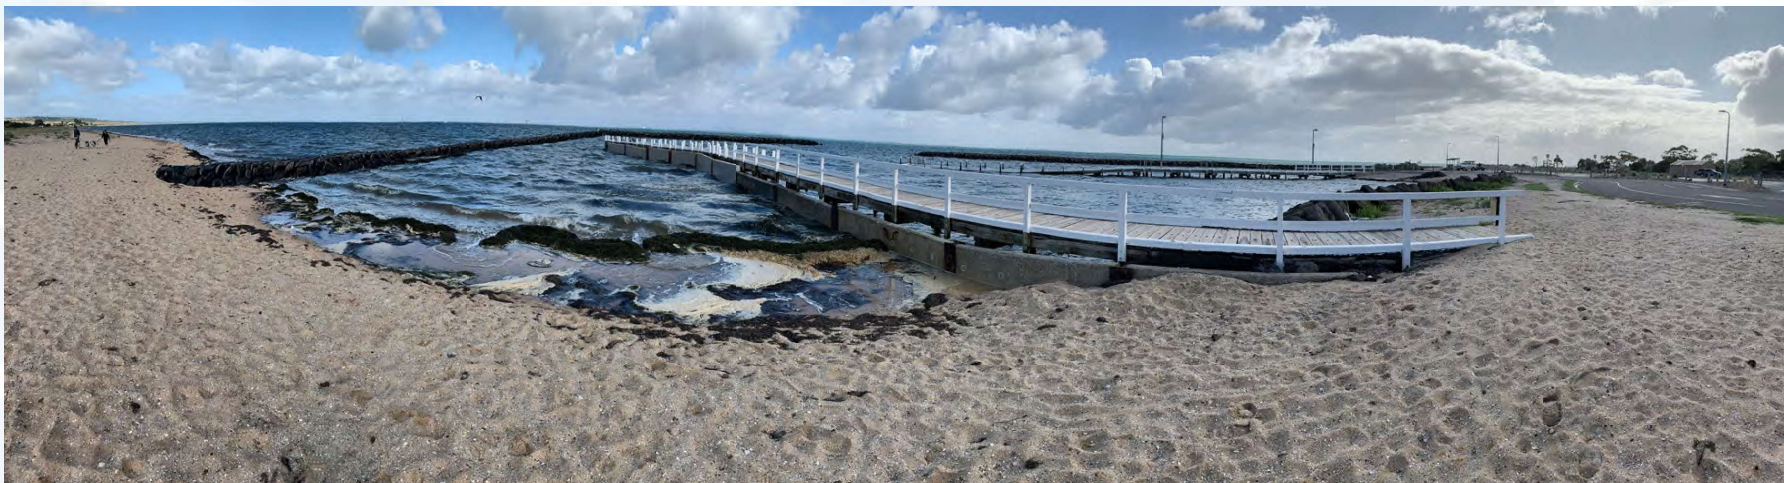
Figure 3: Proposed Breakwater Concept - *artist impression*
